# Rehabilitation Options

September 12, 2019

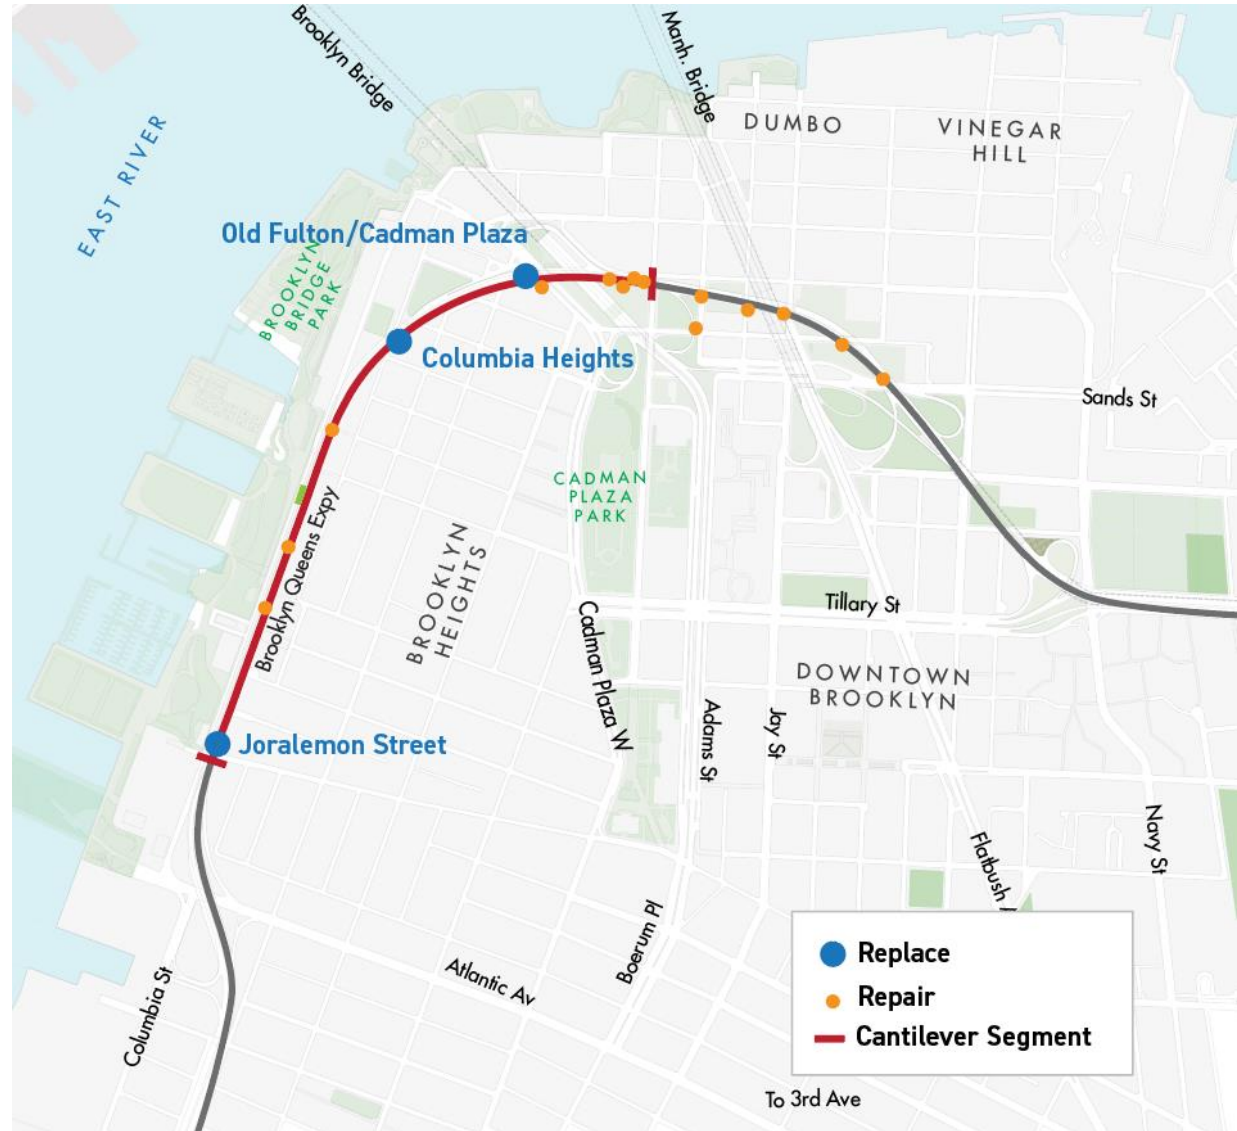
# Common Pain Point: Replacing the Bridges

- Joralemon Street
- Columbia Heights
- Old Fulton/  
Cadman Plaza

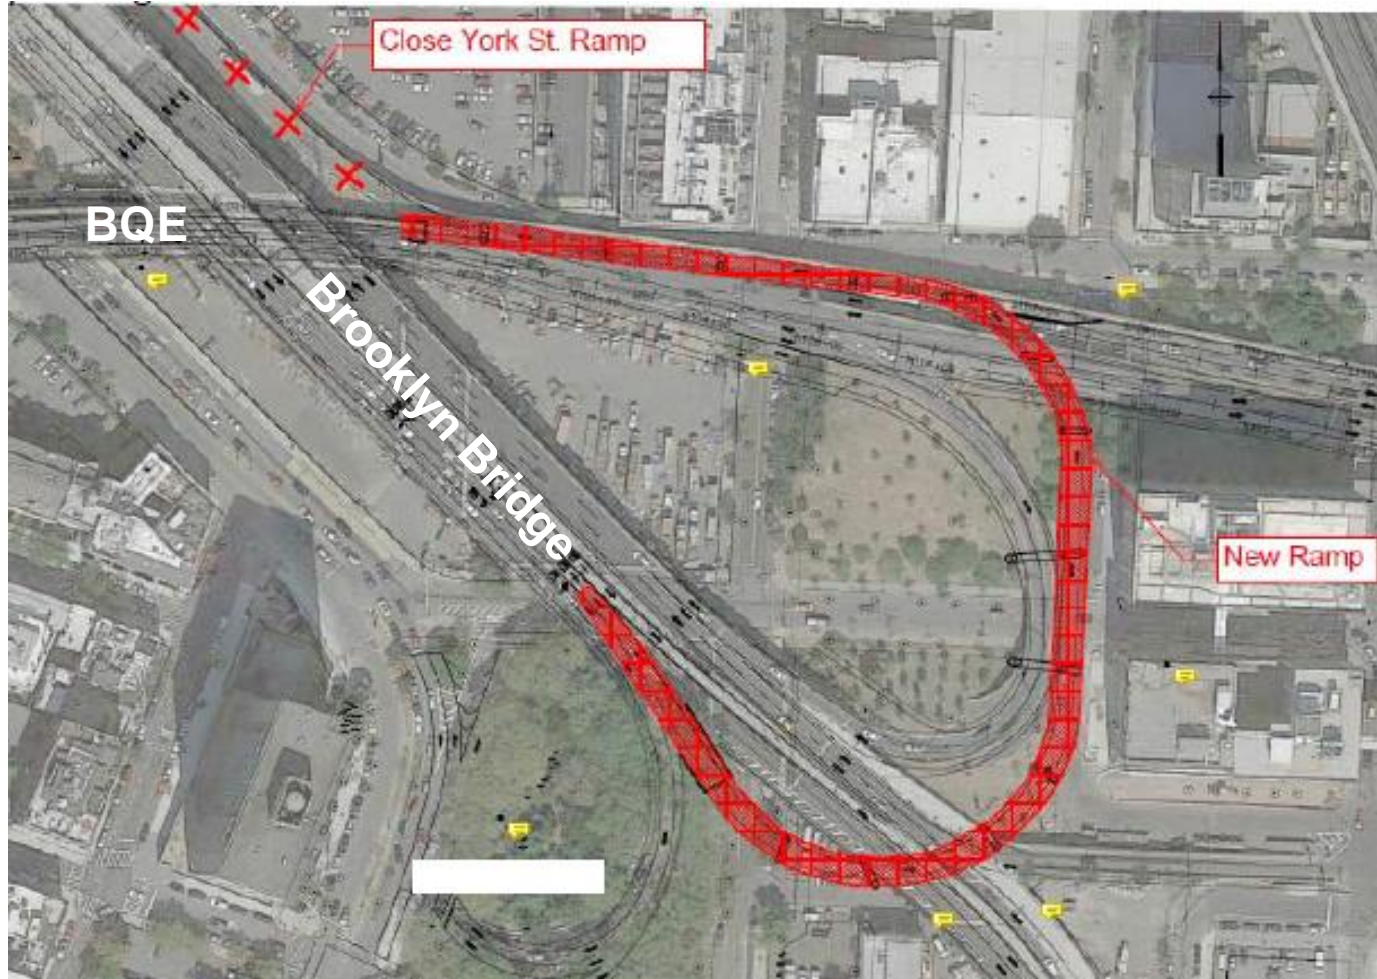
Brooklyn Bridge direct connection requires replacement of a section of BQE

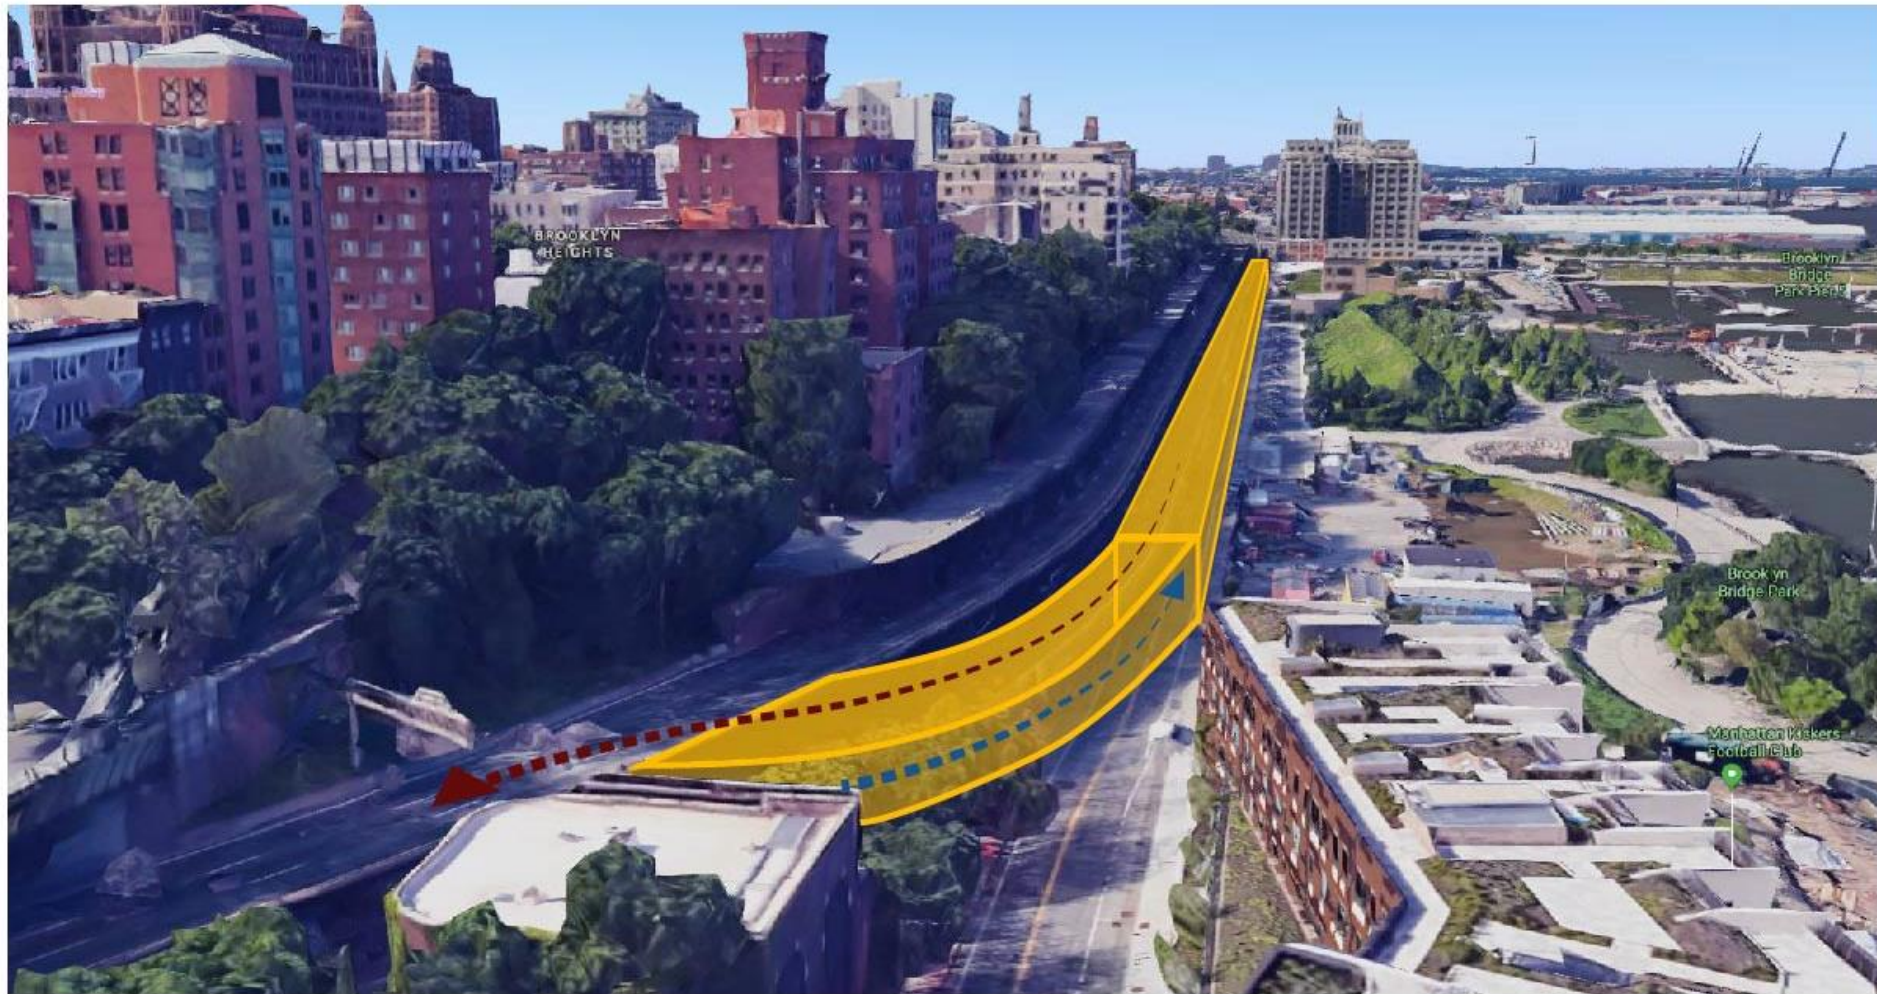
Bypass does not continue into Northern Brooklyn Heights Neighborhood

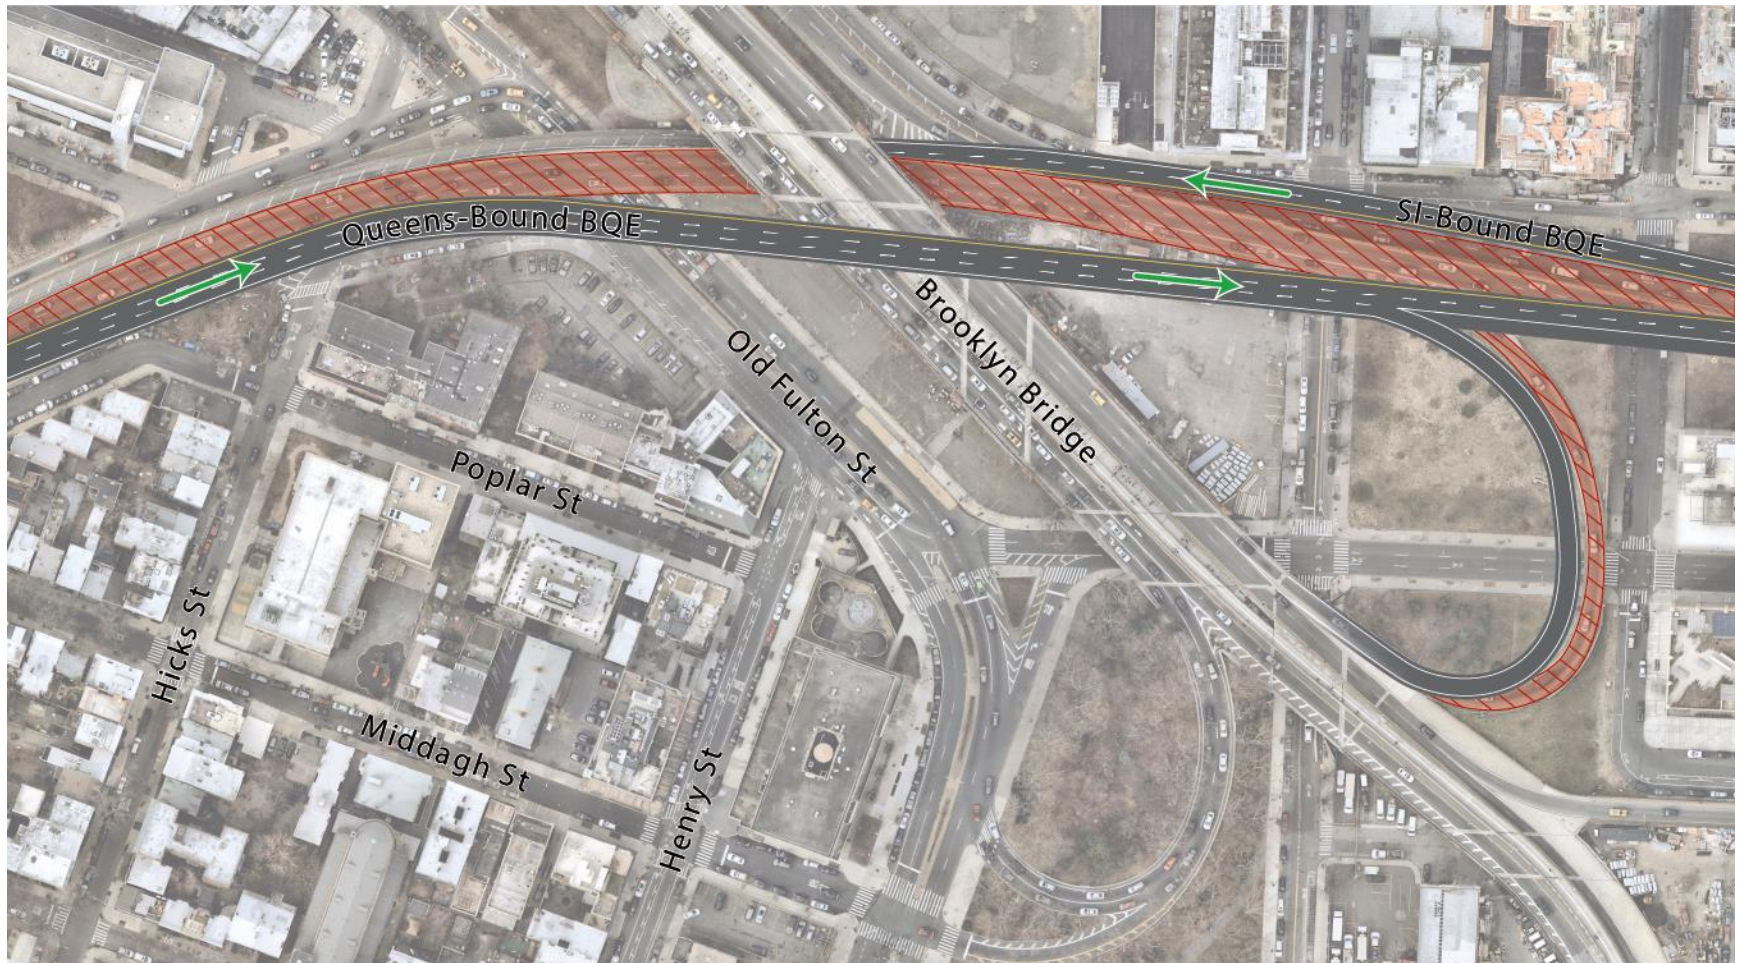
SI Bound – At-grade Section, Lane by Lane  
 QB – Bypass past Columbia Heights Bridge

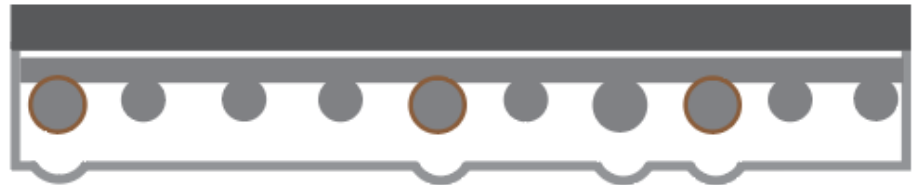
Corrosion

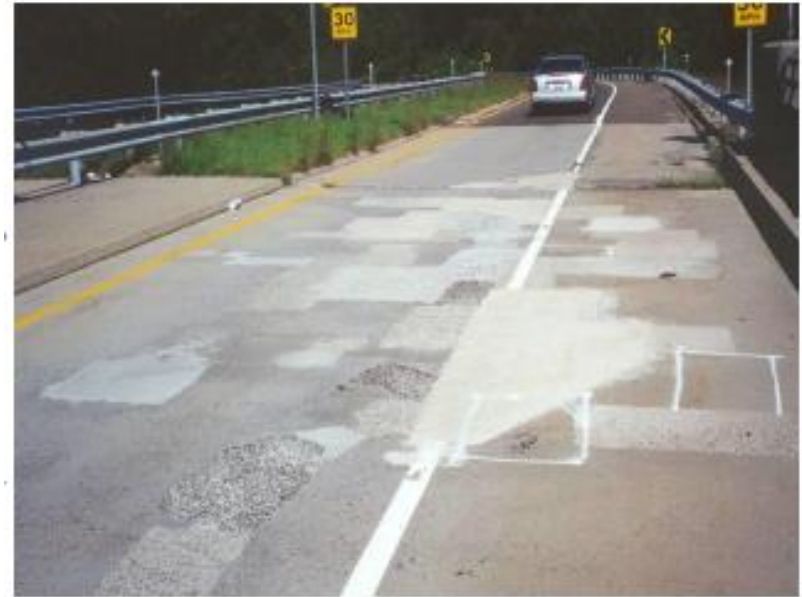
Figure 5. Deck showing halo effect.

- Shortest service life
- Hard to know what conditions will be discovered
- Unrepaired structure continues to decay at unknown rate
- Deck “Halo”
  - Area surrounding the repaired section decays at a rapid rate

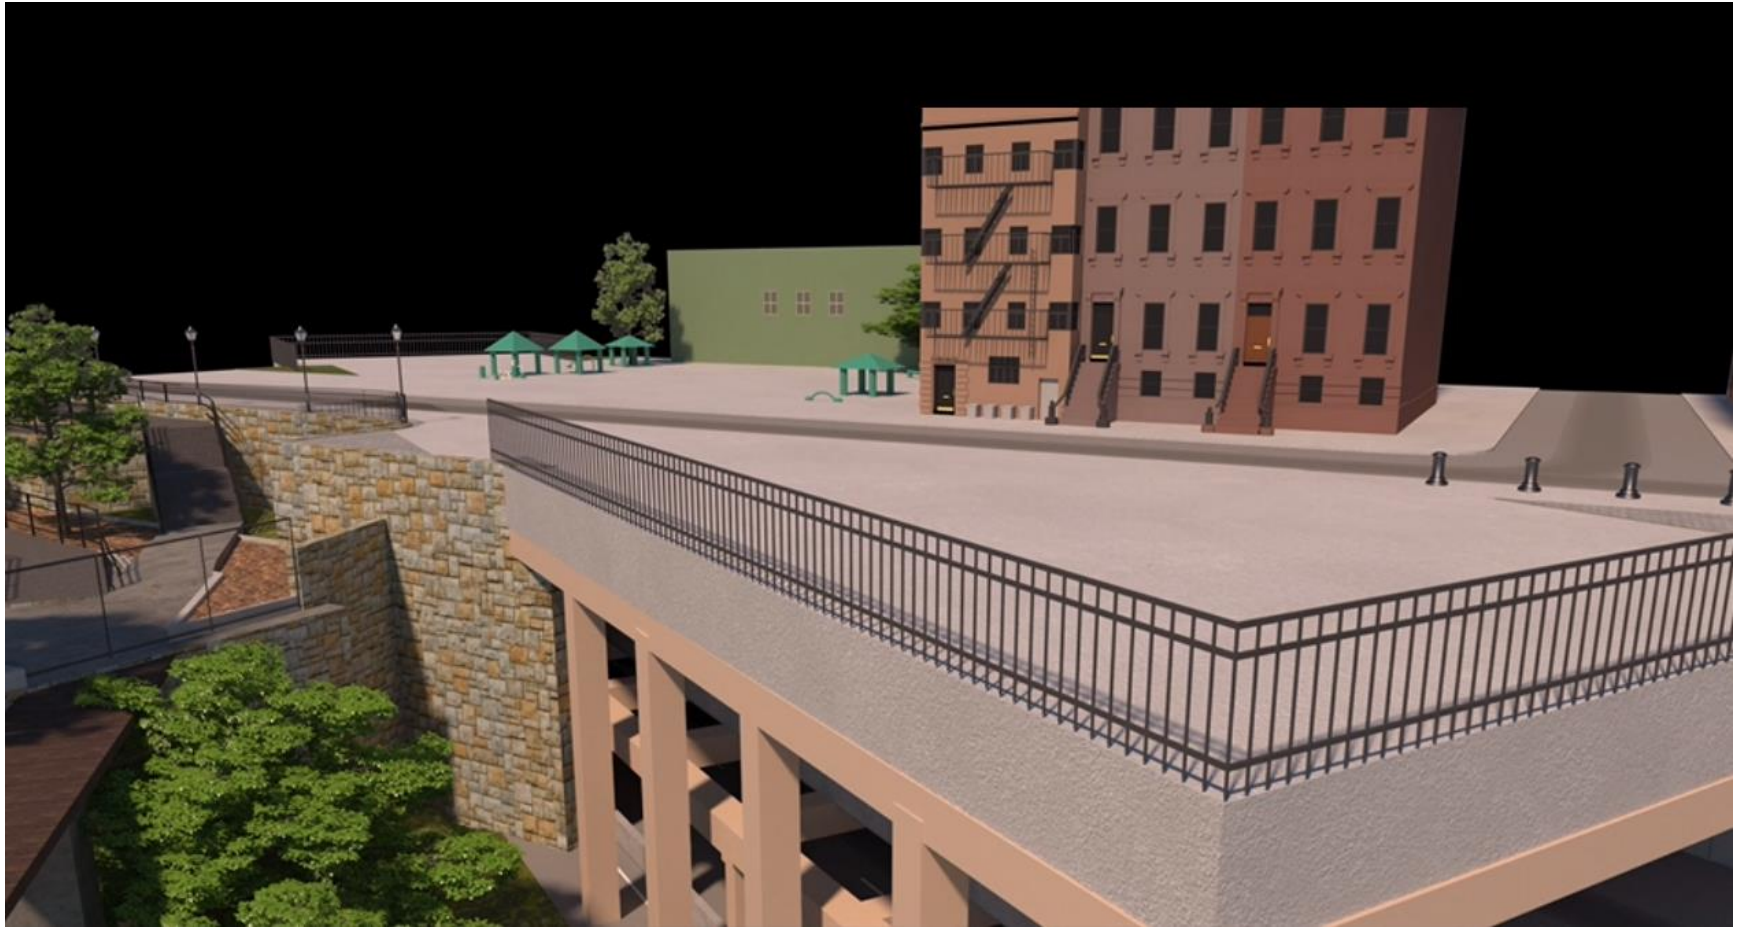
Opportunity for new open space on the north end of the structure

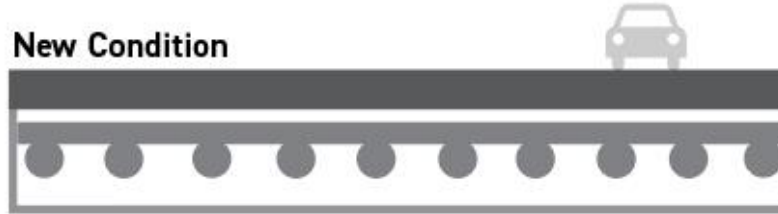
**New Condition**

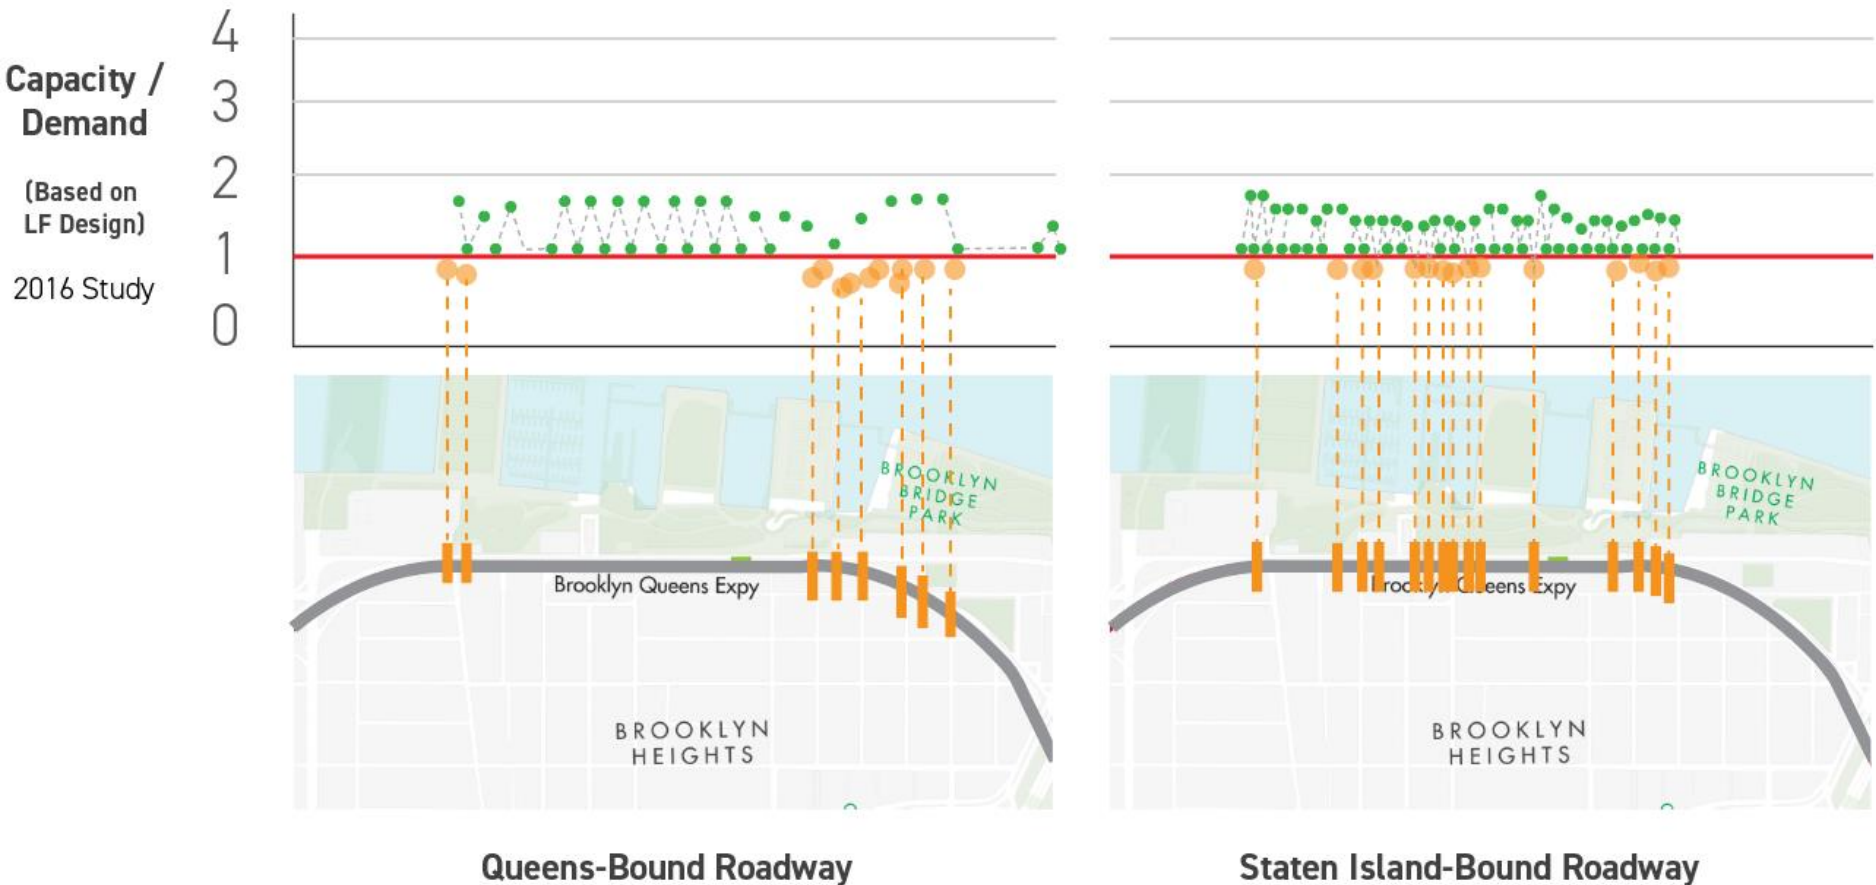
- Many parts of the bridge handle the current load, but heavier loads add risk
- These areas are predicted to increase through 2026

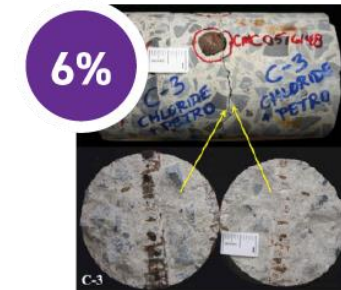
2016 Study

- Corrosion continues at an accelerated pace

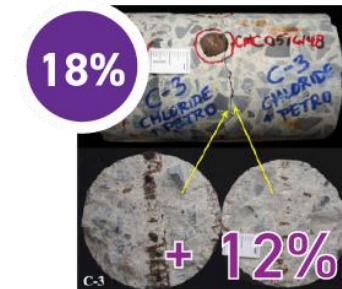
2026 Prediction

- Corrosion continues

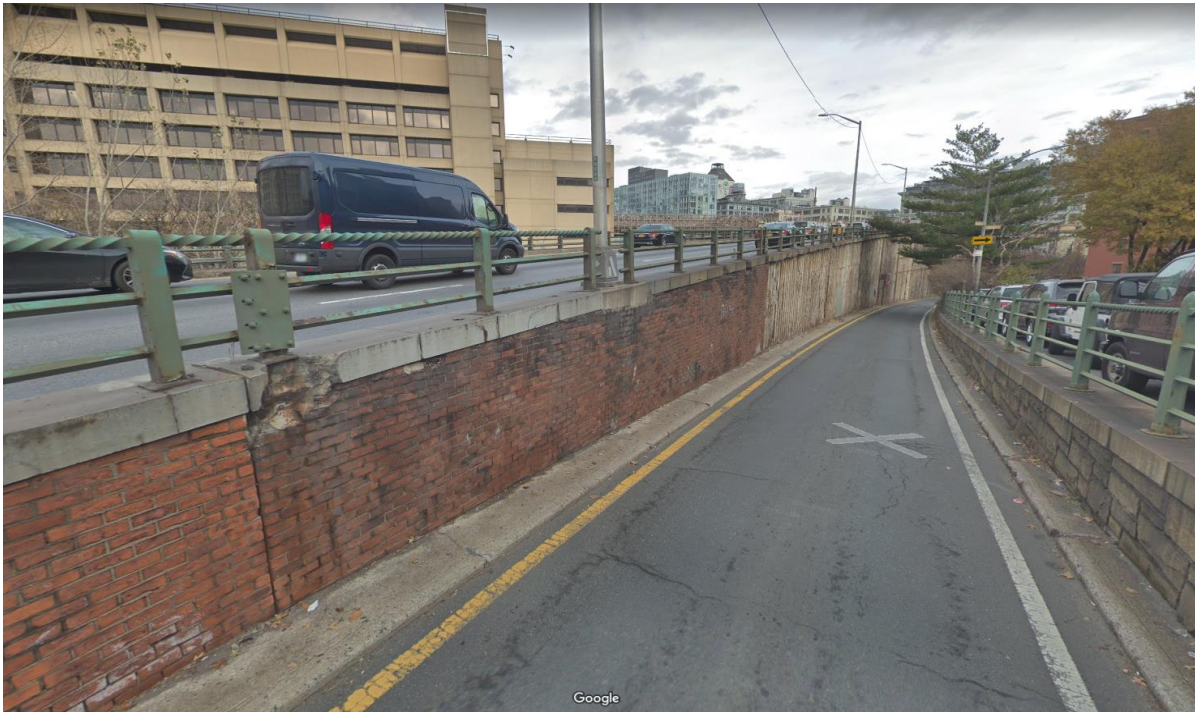
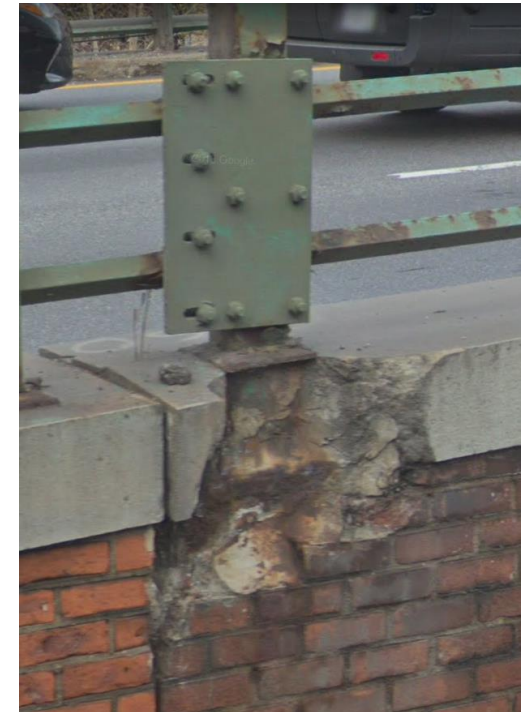
## Yellow Flag Condition – Hicks Street Retaining Wall
