Rehabilitation of Hicks Street Wall

Fall 2020

Hicks Street from BQE exit ramp to Old Fulton Street

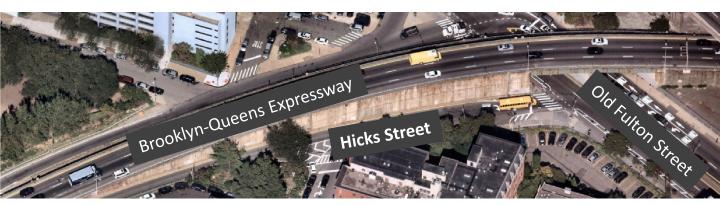
The New York City Department of Transportation (NYCDOT) will soon begin the rehabilitation of the wall supporting the BQE along Hicks Street. The wall supports the exit ramp of Exit 28A of the Queens-bound BQE and provides access to downtown Brooklyn. The Hicks Street wall is a load bearing reinforced concrete wall and is roughly 548' long, and up to 36' high. The wall is deteriorated, missing brick veneer over 90% of its surface area with displaced and cracked coping at the interface between the safety railing and the wall. There are portions of unsound concrete showing spalls as deep as 6", efflorescence, and missing mortar at the joints; exposed reinforcing steel; debonded reinforcing steel; and reinforcing steel with marked section loss. With the deficiencies noted above, the structural integrity of this wall is compromised, and immediate repair is warranted.

Existing condition - Hicks Street wall

- All the existing structural concrete will be removed to 1-2 inches behind the front mat of the existing reinforcement; new rebars will be installed and new concrete will be placed.
- All cracks will be repaired by epoxy injection.
- The curb and safety walk will be removed and replaced.
- The existing electric conduits will be removed and replaced.
